Indonesia: Riau Natural Gas Power Project

Riau 275 MW Combined Cycle Power Plant IPP Project

Lenders Environmental & Social Monitoring Report

June 2020

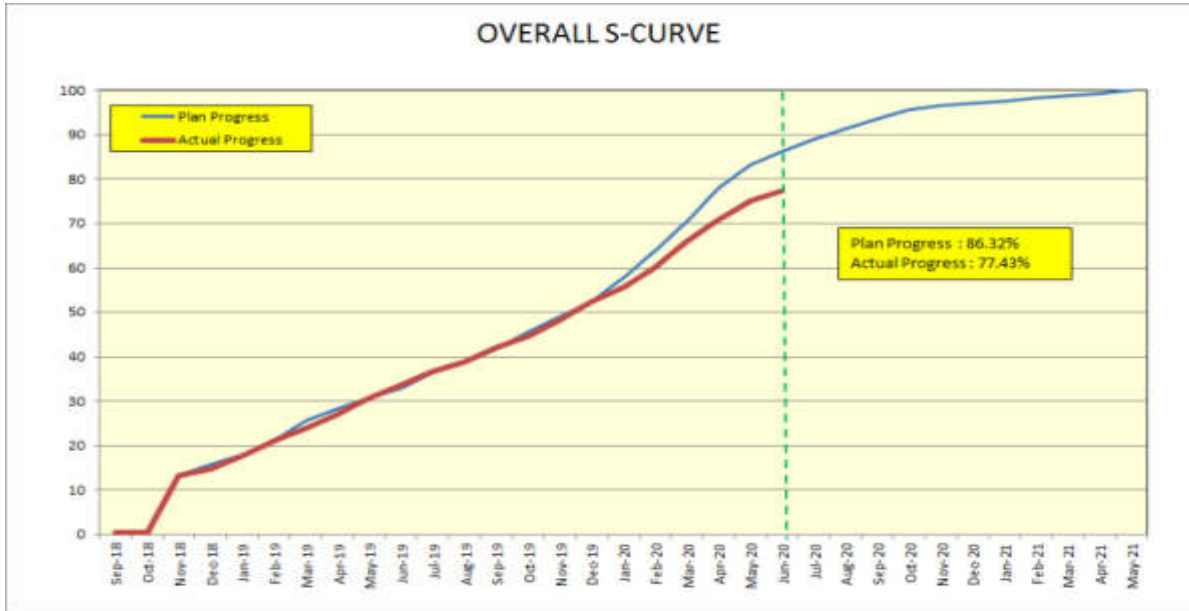
Figure 1.3-1. Power Plant Construction Progress
 Source: EPC Contractors Monthly Report, June 2020

Description	2019							2020						
	Jul-19	Aug-19	Sep-19	Oct-19	Nov-19	Dec-19	Jan-20	Feb-20	Mar-20	Apr-20	May-20	Jun-20	Jul-20	
	11	12	13	14	15	16	17	18	19	20	21	22	23	
Plan	Inc	3.32	2.15	3.32	3.76	3.42	3.35	5.42	5.93	6.77	7.79	5.27	2.92	2.65
	Cumm	36.47	38.62	41.94	45.70	49.12	52.47	57.89	63.82	70.59	78.20	83.35	86.32	88.97
Actual	Inc	3.10	2.05	3.26	2.50	3.69	4.09	3.27	4.56	5.81	4.98	4.06	2.31	
	Cumm	36.85	38.90	42.16	44.66	48.35	52.44	55.71	60.27	66.08	71.06	75.12	77.43

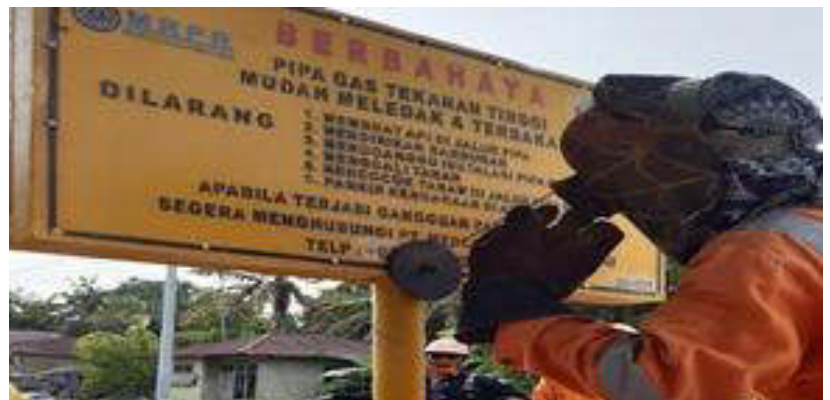
Figure 3.2-3. Installation of Warning Sign Board along Gas Pipeline Route

Apart from the Grievance box in the entrance of the Power Plant Site and EPC Contractor Site Office. MRPR is also in the progress of warning sign board installation along the constructed gas pipeline route. The emergency contact number is also posted at every board.

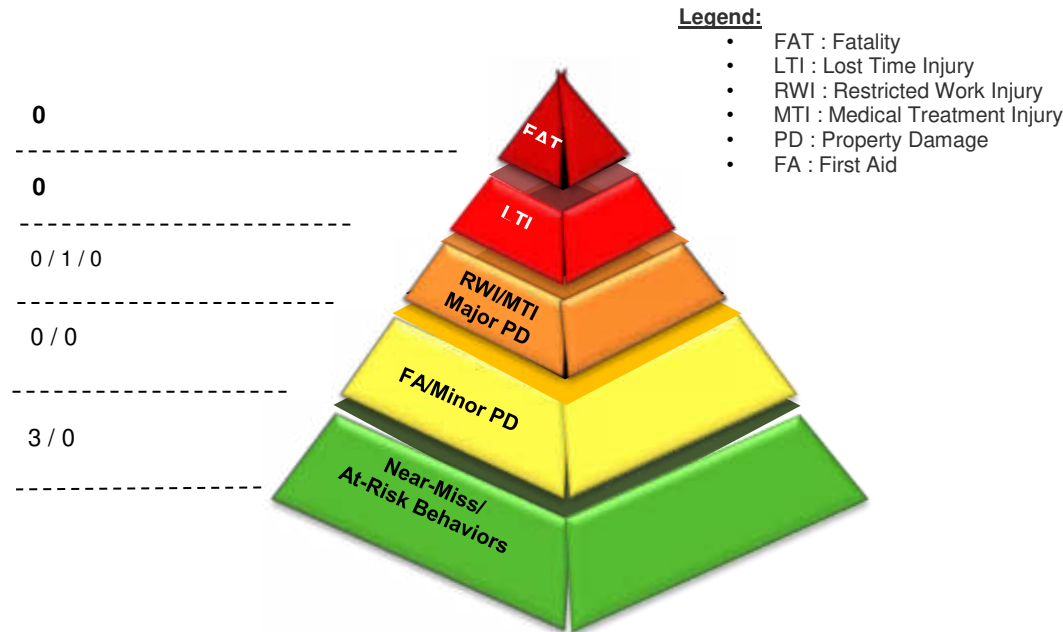
Figure 4.1-1. HSE Statistic

As per 30 June 2020, Safe Man-hours has reached 3,083,591. Overall HSE Status is shown in Table 4.1-1.

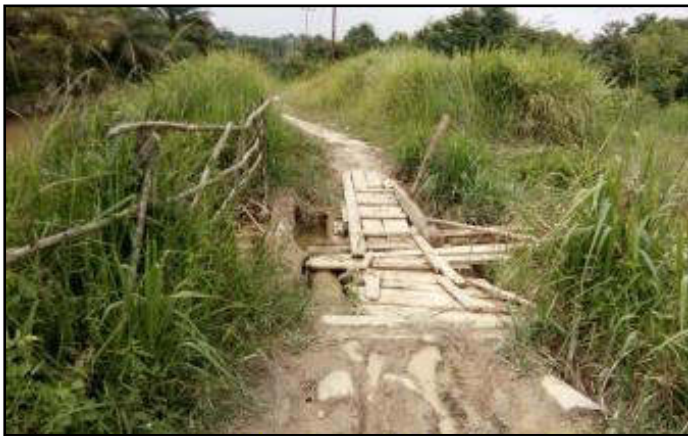
Figure 5.4-7: Bridge at Tenayan pre-construction

Figure 5.4-7 and 5.4-8 show the bridge prior to and post construction.

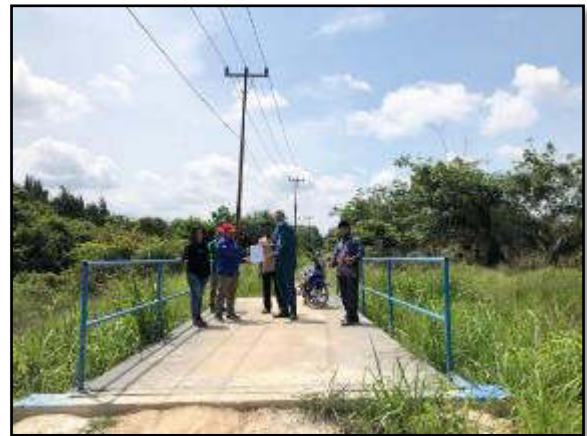
Figure 5.4-8: Bridge at Tenayan post-construction

MRPR is continuing the CSR program for affected villages but due to Covid-19 pandemic situation the program implementation has been limited. However, MRPR were still able to finish a bridge construction at Tenayan Village in July 2020. The bridge improves access to the site by the local workers and increase villagers' mobility.

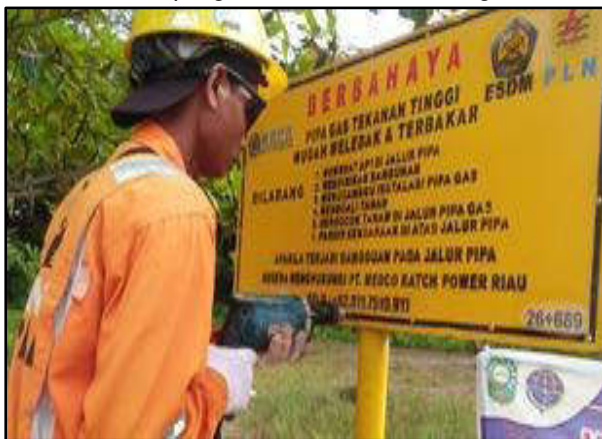
Figure 5.5-1: Sign board is being installed

MRPR is continuing to install sign boards at prominent place to educate people on the potential risks of the gas pipeline installation and to increase community safety awareness. Appendix D presents the location of sign boards installation and progress of installation. Figure 5.5-1 and 5.5-2 show sample of sign boards installed at Project area.

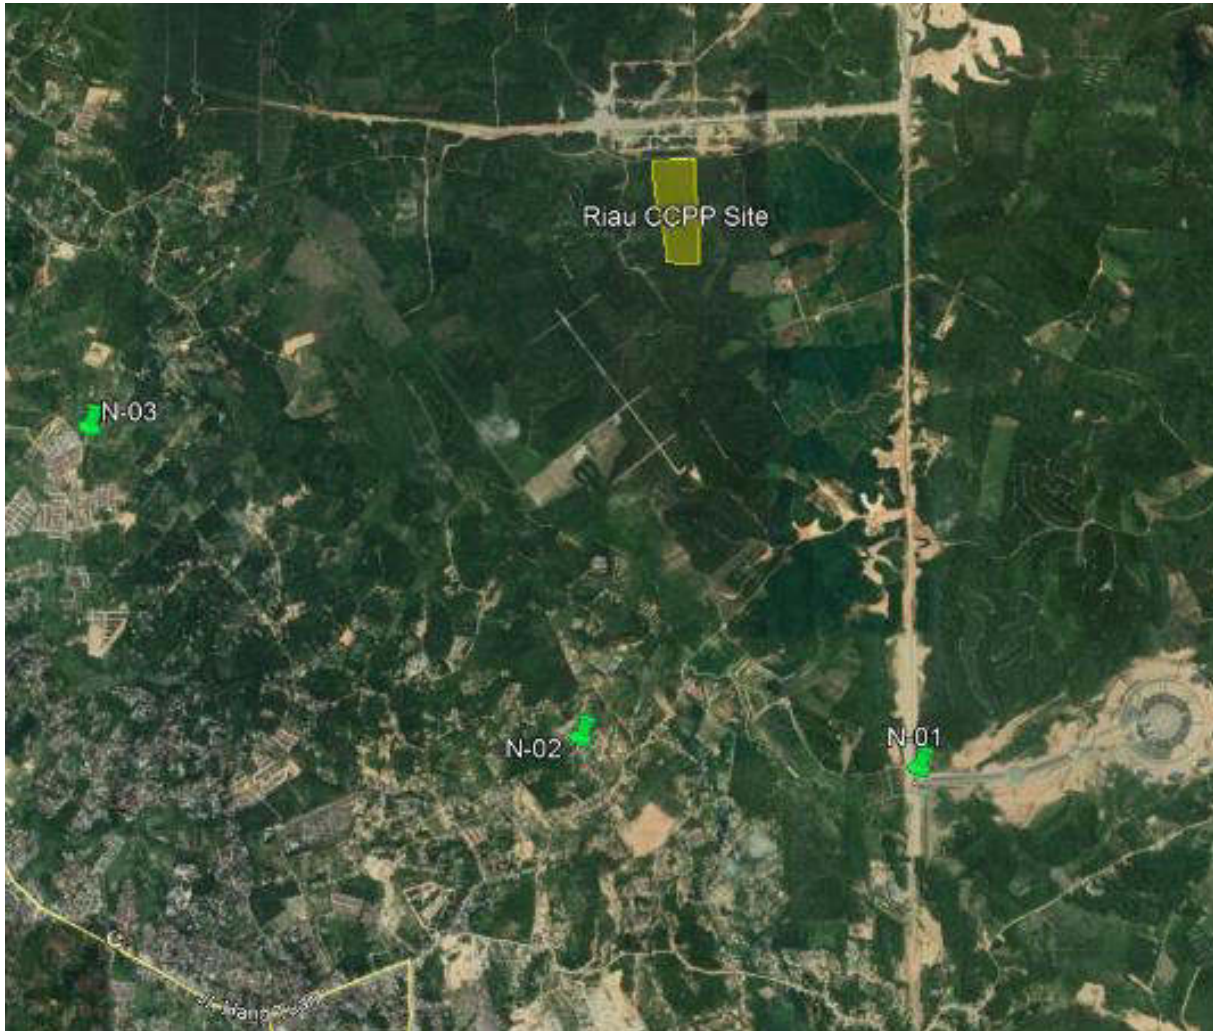
Figure 8.5-1 Noise Monitoring Location.

It is to note that the noise baseline referenced in both tables was undertaken in July 2017. Please refer to the 'ESIA Volume 5: Appendix I. Technical Report – Noise Impact Assessment', (Jacobs, July 2018)' for further details on baseline noise impact assessment. The noise monitoring location for power plant are shown in Figure 8.5-1

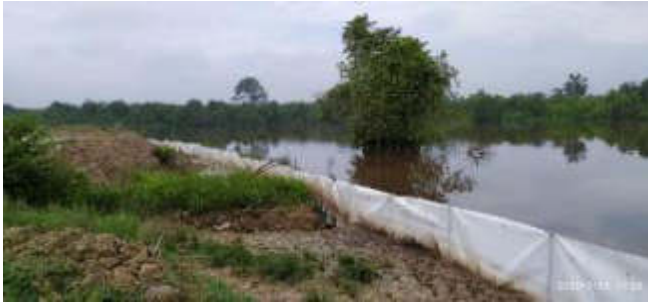
Figure 8.6-1: Silt fencing at the temporary jetty area

Sheet piles were installed at the temporary jetty area in December 2019. Soil resulting from dredging was stock piled and then used to level the jetty area. Silt fencing has also been installed in the area for erosion control measures (Figure 8.6-1). Silt curtains have been installed during dredging operations (Figure 8.6-2). The temporary jetty construction has been completed in early July 2020.

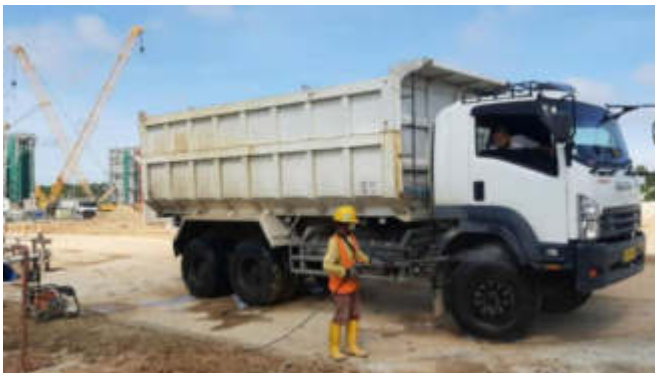
Figure 8.6-3: Wheel Cleaning at Wheel Washing Facilities at Power Plant Site

Wheel washing facilities has been provided on-site. See Figure 8.6-3

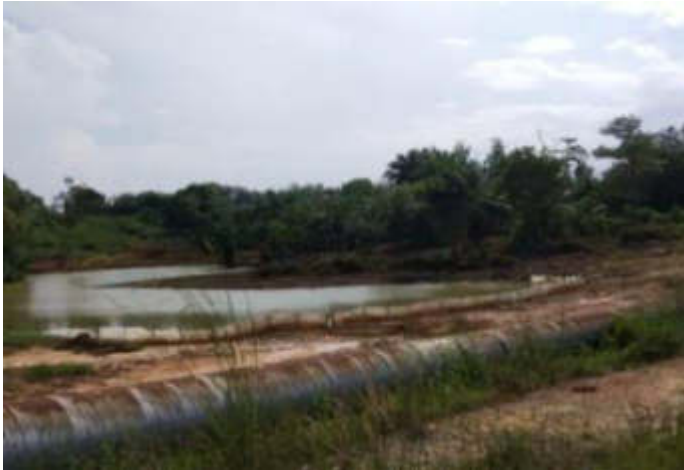
Figure 8.6-4: Silt fence installation to avoid runoff surface during heavy rainfall at water pond area (KP 07)

Silt fencing was installed during gas pipeline construction associated with river crossings and working adjacent to waterbodies e.g. swamp at (KP 07) in the Natural Habitat Area (See Figure 8.6-4). In addition, regular spot checks have been conducted at the installed silt fence. In the adjacent area at KP-07 CPM conducted a repair of slope area next to graveyard location to stabilize the slope.

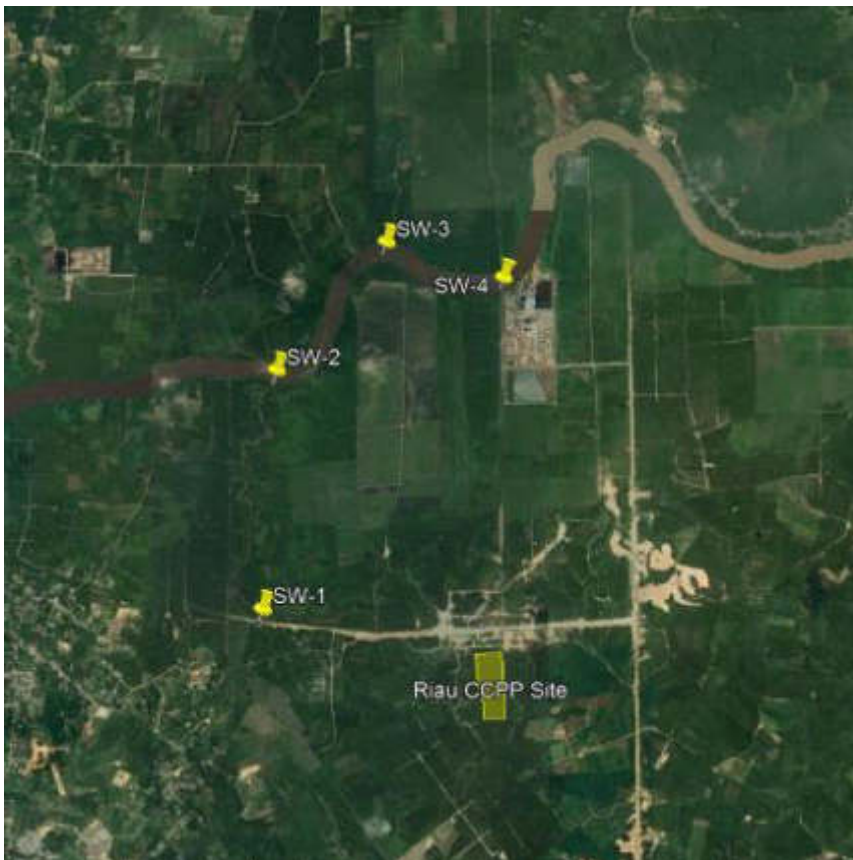
Figure 8.7-1 Surface water sampling locations

The surface water quality monitoring was conducted quarterly in Dec 2019, March and May 2020 at four sampling locations (see Figure 8.7-1). The results were compared against standards on Government Regulation No 82 of 2001 for surface water class II.

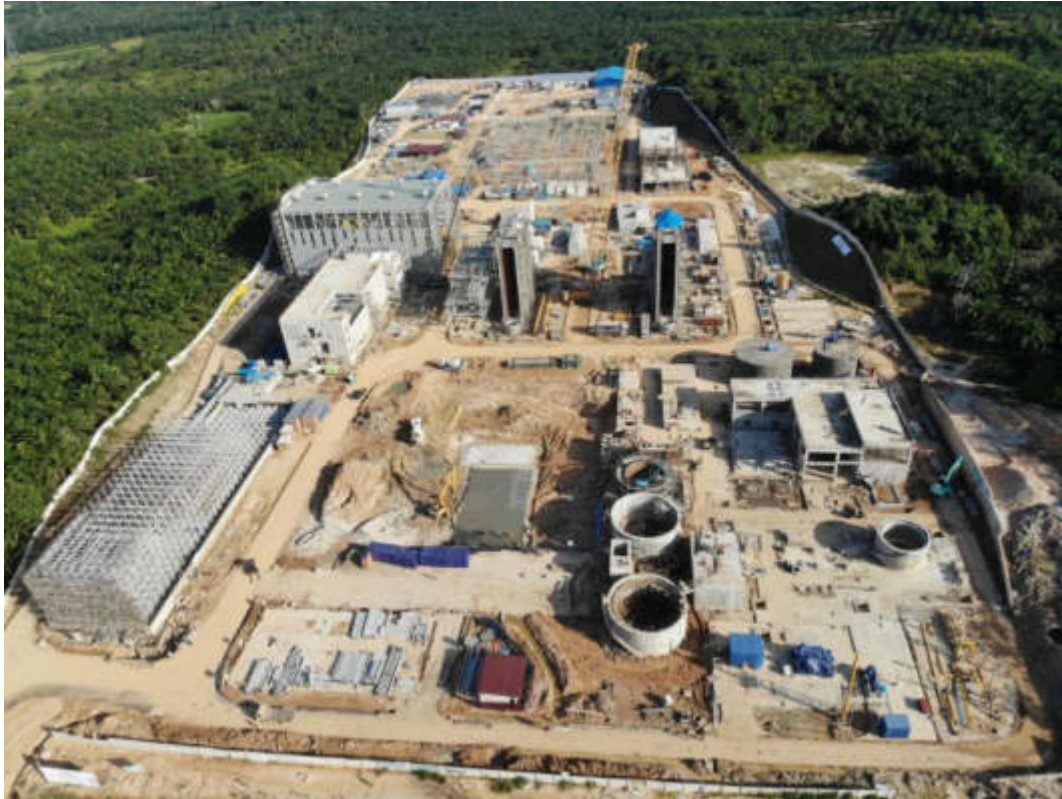
Figure 8.13-1. Fencing Around the Power Plant Site

Project site is landscaped to improve visual amenity. Power Plant project area is properly fenced but given that the on-going construction, trees planting is not yet started but shrubs and grass are planted. Figure 8.13-1 shows the site fencing and improved landscape of project area.

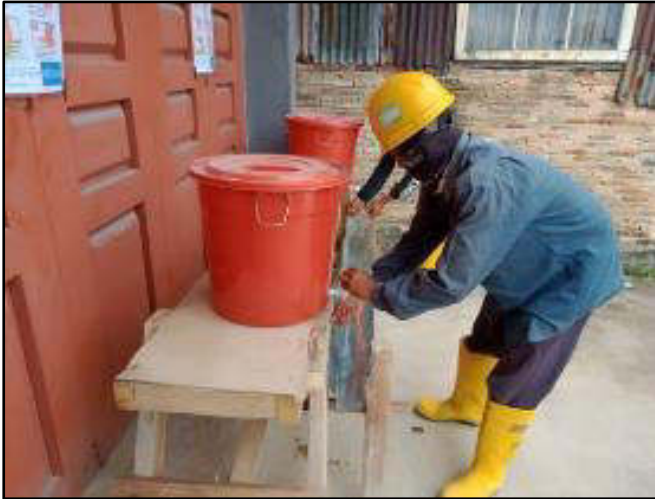
Figure 8.15-5: HK new accommodation – hand wash

HK provides new accommodation (Figure 8.15.3 and 8.15.4) for the workers following the Lenders audit findings in October 2019. The first batch of mobilization involving 100 construction workers is completed mid of March 2020. The second batch is completed in May 2020. Upon mobilization, the old HK1 and HK2 accommodations were demolished.

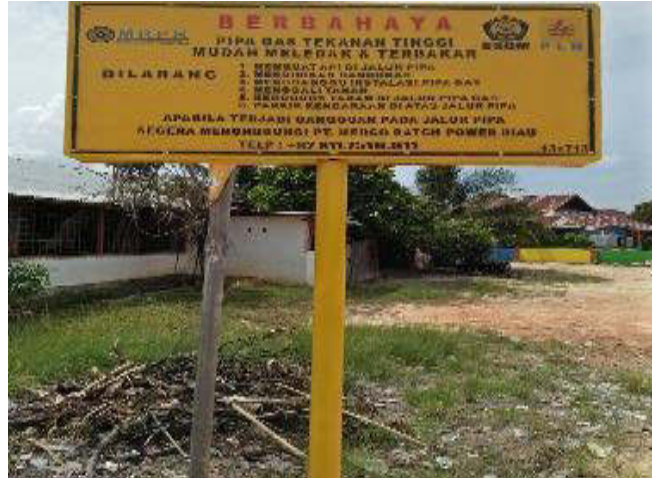
Figure 8.16-2: Emergency Contact Number posted at Sign Board Along Gas Pipeline Route

MRPR posted emergency contact number and call out procedure on prominent location at Project area (Figure 8.16.1 and 8.16.2), including announcement board at village area (Figure 8.16.3 and 8.16.4). The emergency contact number is also presented at warning sign board that is being installed along the constructed gas pipeline route.

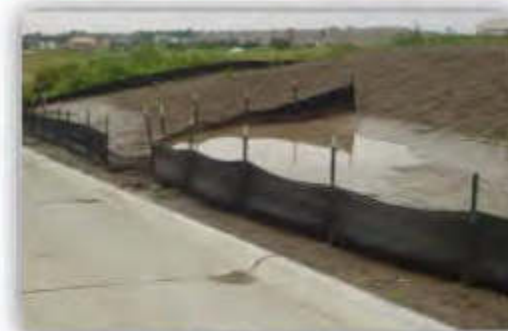
Silt Fence

- **Potensi Erosi ditimbulkan oleh:**
 - Limpasan air yang tidak terkontrol
 - Pergesekan tanah dengan kendaraan
 - Pekerjaan penggalian, pengupasan permukaan dan penggalian parit.
- **Usaha pencegahan erosi:**
 1. Pengarahan aliran air menghindari lereng dan permukaan tanah terbuka
 2. Penanaman tanaman penutup seperti rumput, dll.
 3. Penutupan tanah sementara dengan bahan penutup seperti terpal, dll
 4. Pemasangan *Silt Fence*
 5. Penguatan lereng dengan Riprap batu, gabion atau bronjong
 6. Pembuatan Sediment Pond

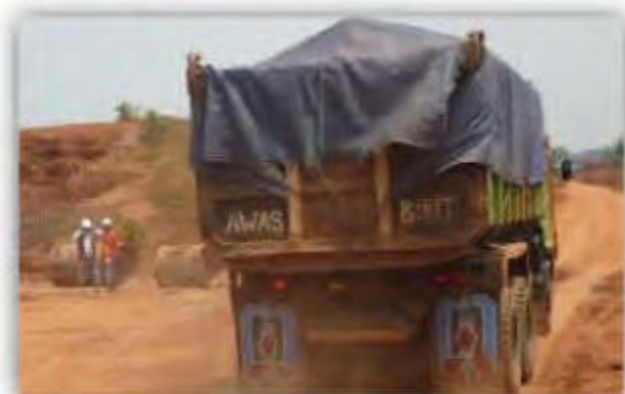
Penutupan dengan Terpal

- **Potensi Polusi Udara ditimbulkan oleh:**
 - Debu kegiatan dan kendaraan
 - Emisi mesin, alat berat dan kendaraan
- **Usaha pencegahan polusi udara:**
 1. Pencucian roda kendaraan
 2. Penyiraman jalan dan lokasi kerja
 3. Pembatasan kecepatan kendaraan
 4. Penutupan truk tanah dengan terpal
 5. Penutupan area kerja blasting
 6. Pelarangan kegiatan *open burning*
 7. Perawatan mesin untuk menjaga emisi berada dibawah baku mutu lingkungan
 8. Melakukan pemantauan kualitas udara ambien.

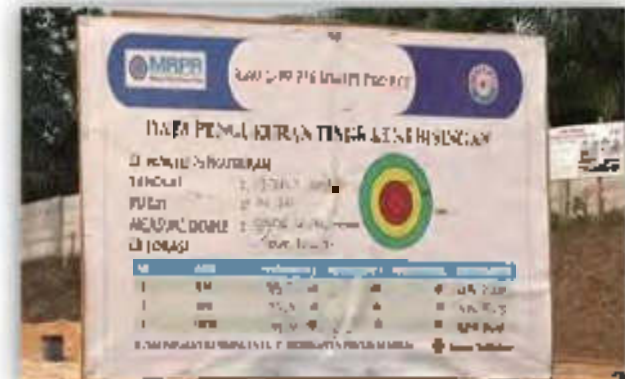
Silent Type Generator

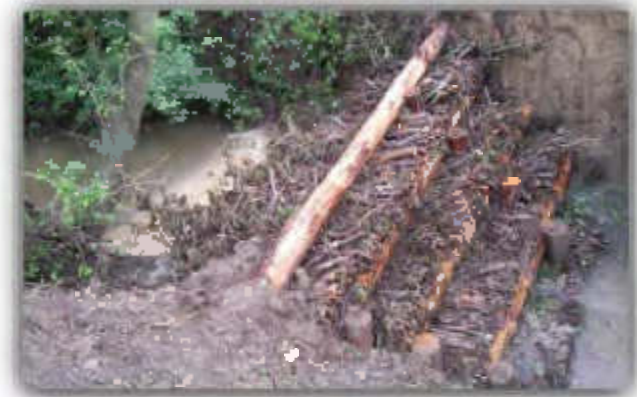
Sediment Pond

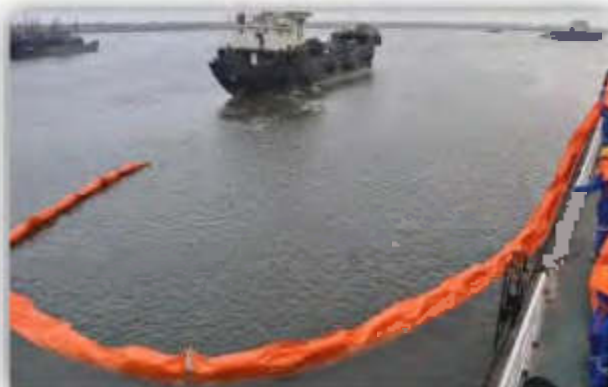
Sistem Tanggap Darurat Tumpahan

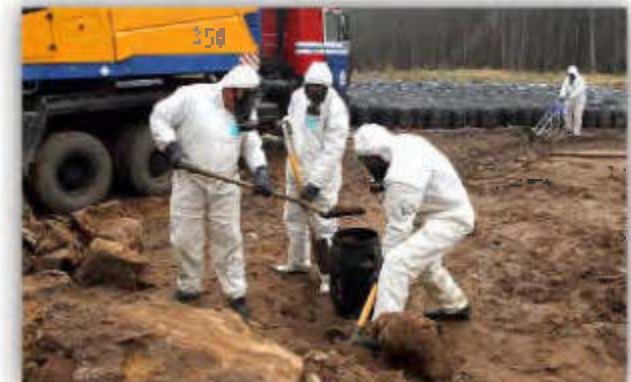
Penanganan Tanah Terkontaminasi

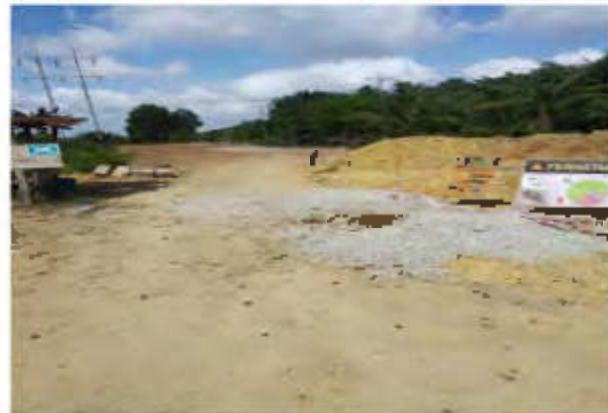
Excavation pit beside access road for people nearby

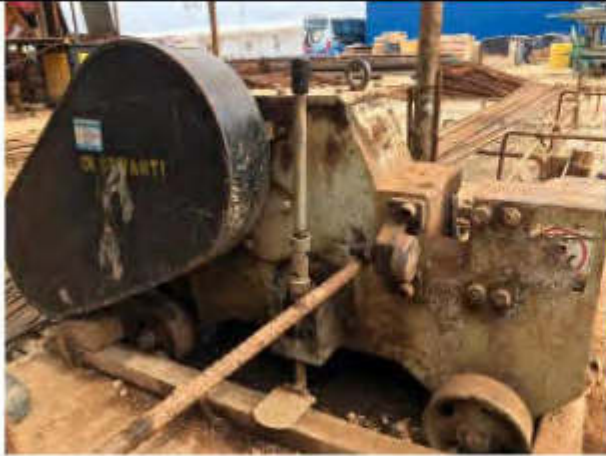
Rebar Equipment

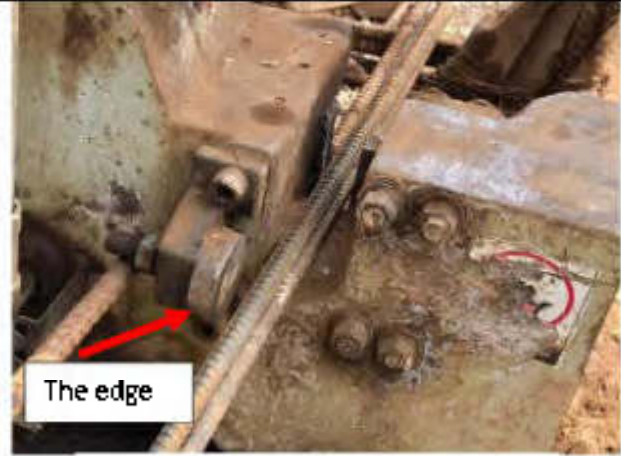
The edge

Rebar Position and Pinch Point

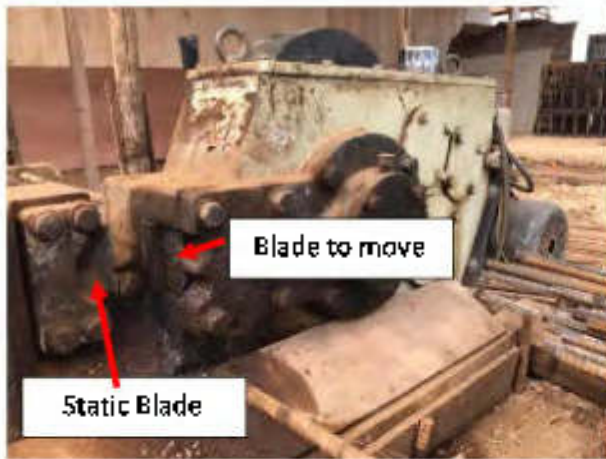
Why 1:	- IP did not wear proper PPE, Hand Glove with Heavy Duty Resistant. - Un-authorized person to operate the rebar bending equipment.
---------------	---

Rebar Position and Pinch Point

Lessons Learnt	<ul style="list-style-type: none"> - Only Authorized person is permitted to operate the equipment. - Implement PPE Selection base on Job risk. Heavy Duty Resistant hand glove shall worn for respective pinch point risk.

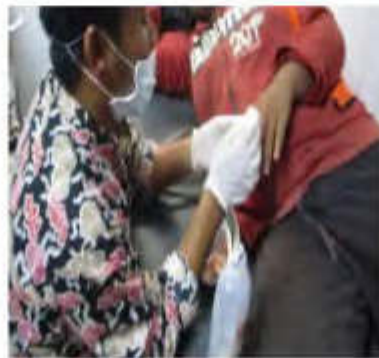
Treatment

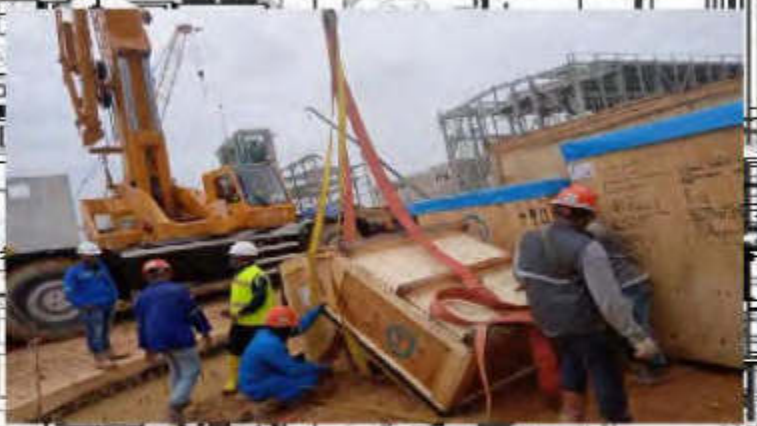
INCIDENT SKETCH & CHRONOLOGY

The load was lifted using four sling belts with basket method on two boxes at one stacking. When the operator lowering load to laydown area, the operator was lowering on the uneven ground condition and caused material on the top unbalanced. The operator immediately sling up the crane then makes the load hit another material and the loads fell down and resulting wooden box material is broken.

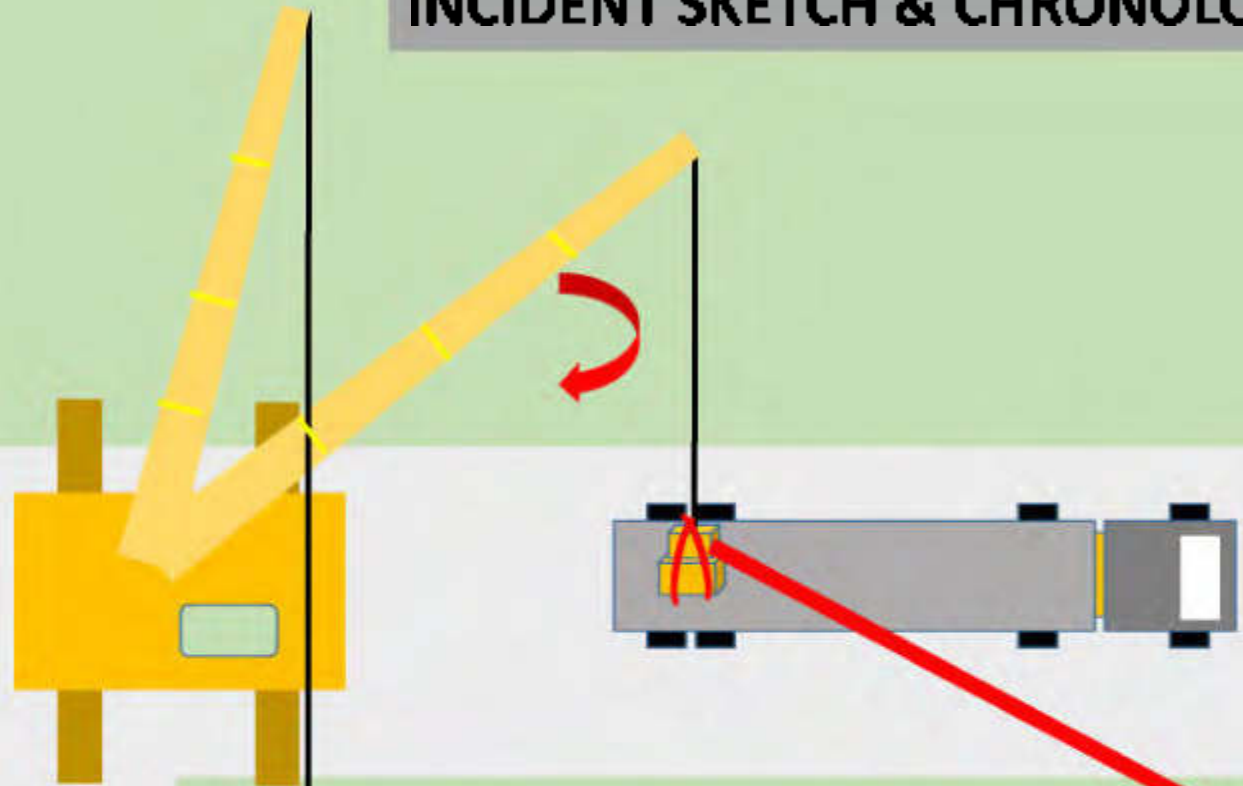
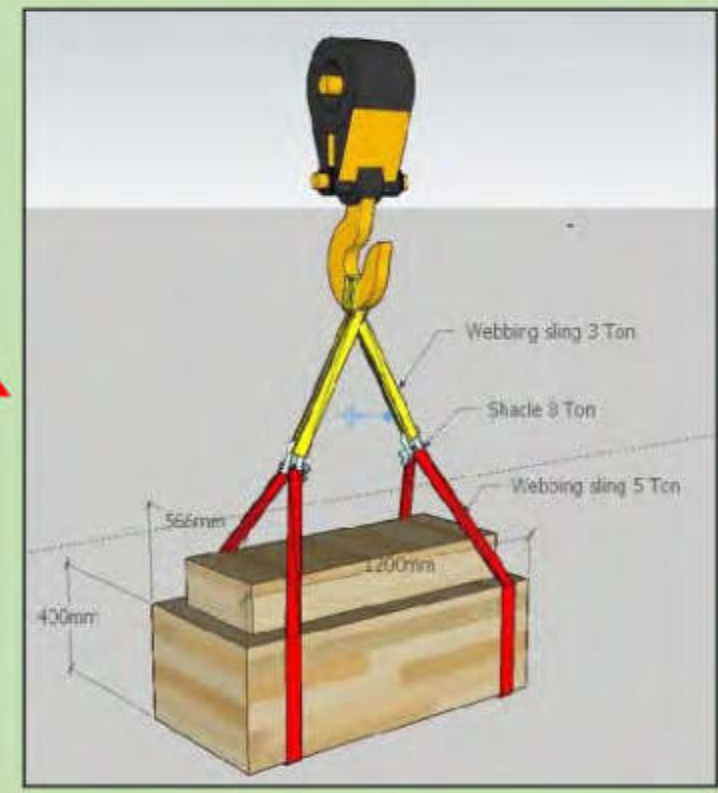
INCIDENT SKETCH & CHRONOLOGY

Uneven ground

Hit point

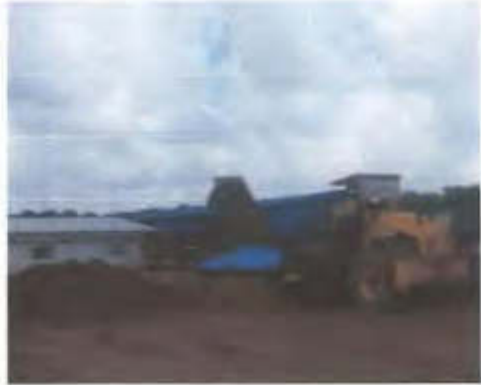
No	Action	Action by	Due Date	Corrective Action	Action Date	Status
1	Contractor to conduct training refreshment to operator and rigger to reinforce the responsibility	RJO	15 June 2020	Training Attached report attached	26 May 2020	Closed
2	Prepare ground level of laydown prior to material placement	RJO/IT	15 June 2020	Contractor Compact laydown prior to use

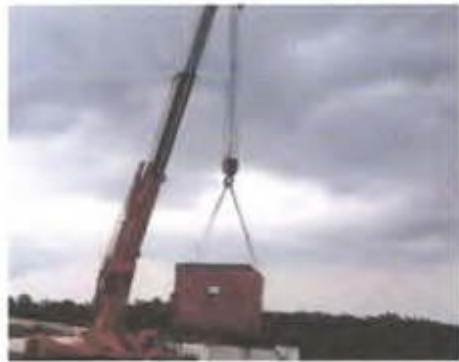
07 June 2020	Closed
3	Rigger to using proper webbing sling/lifting gear according to material weight or specification.	RJO/IT	15 June 2020	Lifting using correct lifting gear

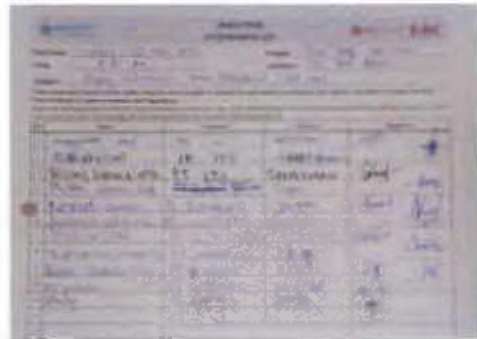
21 May 2020	Closed
4	ITI to increase number of safety personnel to monitor loading/unloading material to prevent any lack of monitoring	ITI	15 June 2020	ITI has been added 3 HSE personnel

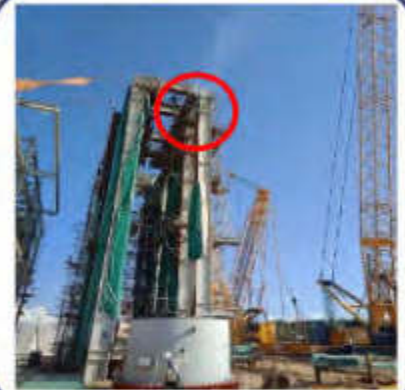
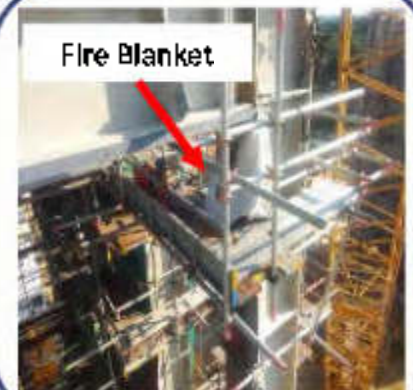
Attached Pictures:

On Tuesday, June 02nd, 2020, approximately 03.50 PM welder conducted welding of column of HRSG 12 at top west side area on coloum G. While welder conducted the welding the spark fell down through the hole between H-beam and fire blanket to the cover of column that consisting from green sheet, plastic transparan, and carton at time the cover immediately get burned.

- No fire extinguisher and fire watcher standby on the scene.
- Improper fire blanket installation.

1. Provide fire extinguisher near to hot work area
2. Assign fire watcher for hot work activity
3. Conduct refresh training of Fire Prevention Procedure for Hot Work Activity to contractor

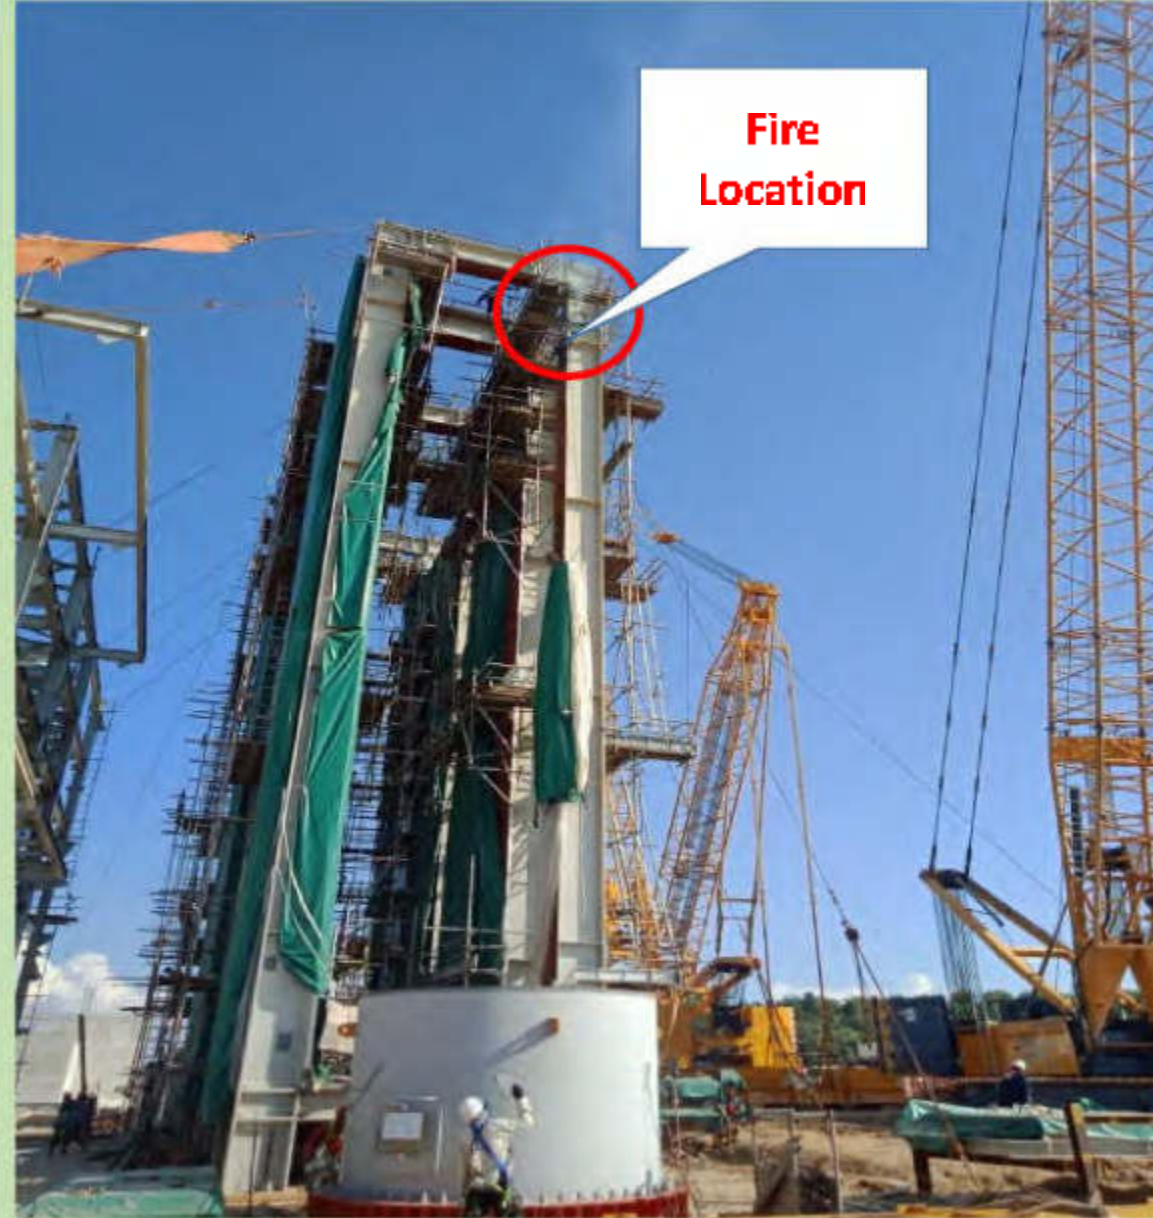
INCIDENT SKETCH & CHRONOLOGY

A welder conducted the welding the spark fell down through the hole between H-beam and fire blanket to the cover of column that consisting from green sheet, plastic transparan. and carton on about elevation 23 meters at time the cover immediately get burned.

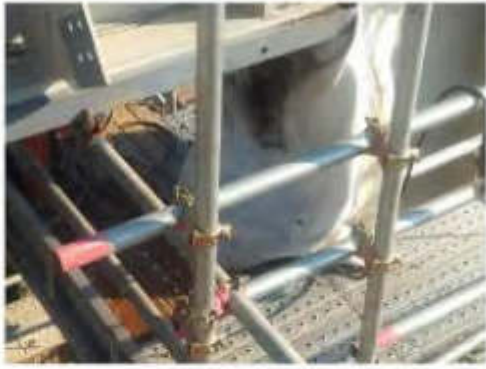
No	Action	Action by	Due Date	Corrective Action	Action Date	Status
1	Sub contractor to provide sufficient number of fire extinguisher	RJO	20 June 2020	Fire Extinguisher register Attached	15 June 2020	Closed
2	Sub contractor to assign fire watcher to monitor hot work activity	ITI	20 June 2020	Fire Watcher List Attached	15 June 2020	Closed
3	Sub contractor to install proper fire blanket to control spark from hot work activity	RJO	20 June 2020

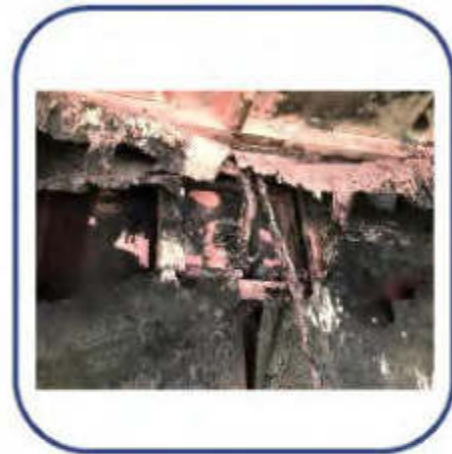
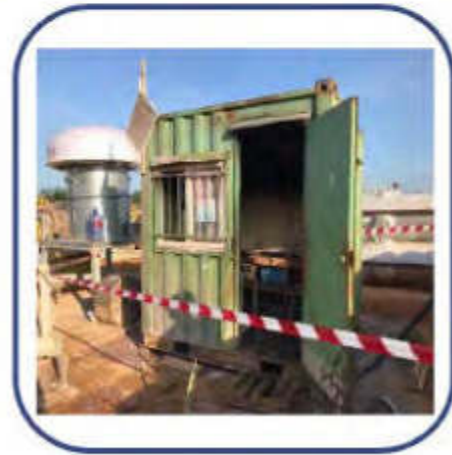
Near miss – Fire occurred in Temporary Security Post

4	9 Jun 2020	<u>Category: Near Miss</u> On 9 June 2020, a security guard left his temporary security post to monitor the subcontractor' lay down area. At that time, he saw smoke was coming out from security post. He immediately went back to the post and extinguished fire together with the fire team using the nearest fire extinguishers. Based on the investigation, the fire was caused by electrical short circuit and the circuit breaker was failed. No Injury was recorded.

No	Action	Action by	Due Date	Corrective Action	Action Date	Status
1	Sub contractor to conduct periodic inspection of electrical installation for temporary facility	JK	30 June 2020	<ul style="list-style-type: none"> Electrical panel inspection has been done

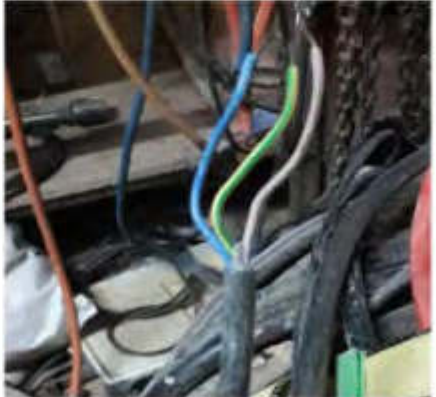
30 June 2020	Closed
2	Sub Contractor to use cable that complete with grounding for temporary facility	JK	30 June 2020	<ul style="list-style-type: none"> Cable completed with grounding has been installed

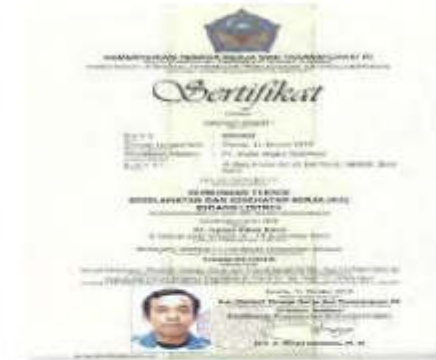
30 June 2020	Closed
3	Sub contractor to hire Expert of electrician (Ahli K3 Listrik)	JK	30 June 2020	<ul style="list-style-type: none"> Certified Electrical Technician has been hired Instead off Expert of electrician (Ahli K3 Listrik)

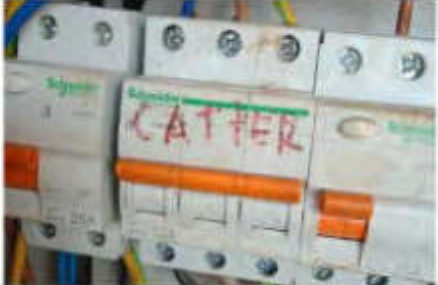
4	Contractor to provide suitable circuit breaker for power socket extension	JK	30 June 2020	Proper circuit breaker has been Installed
